# Hangman Creek Stabilization & Restoration: Methods to the Madness

**Presenter:**  
**Dan Ross**

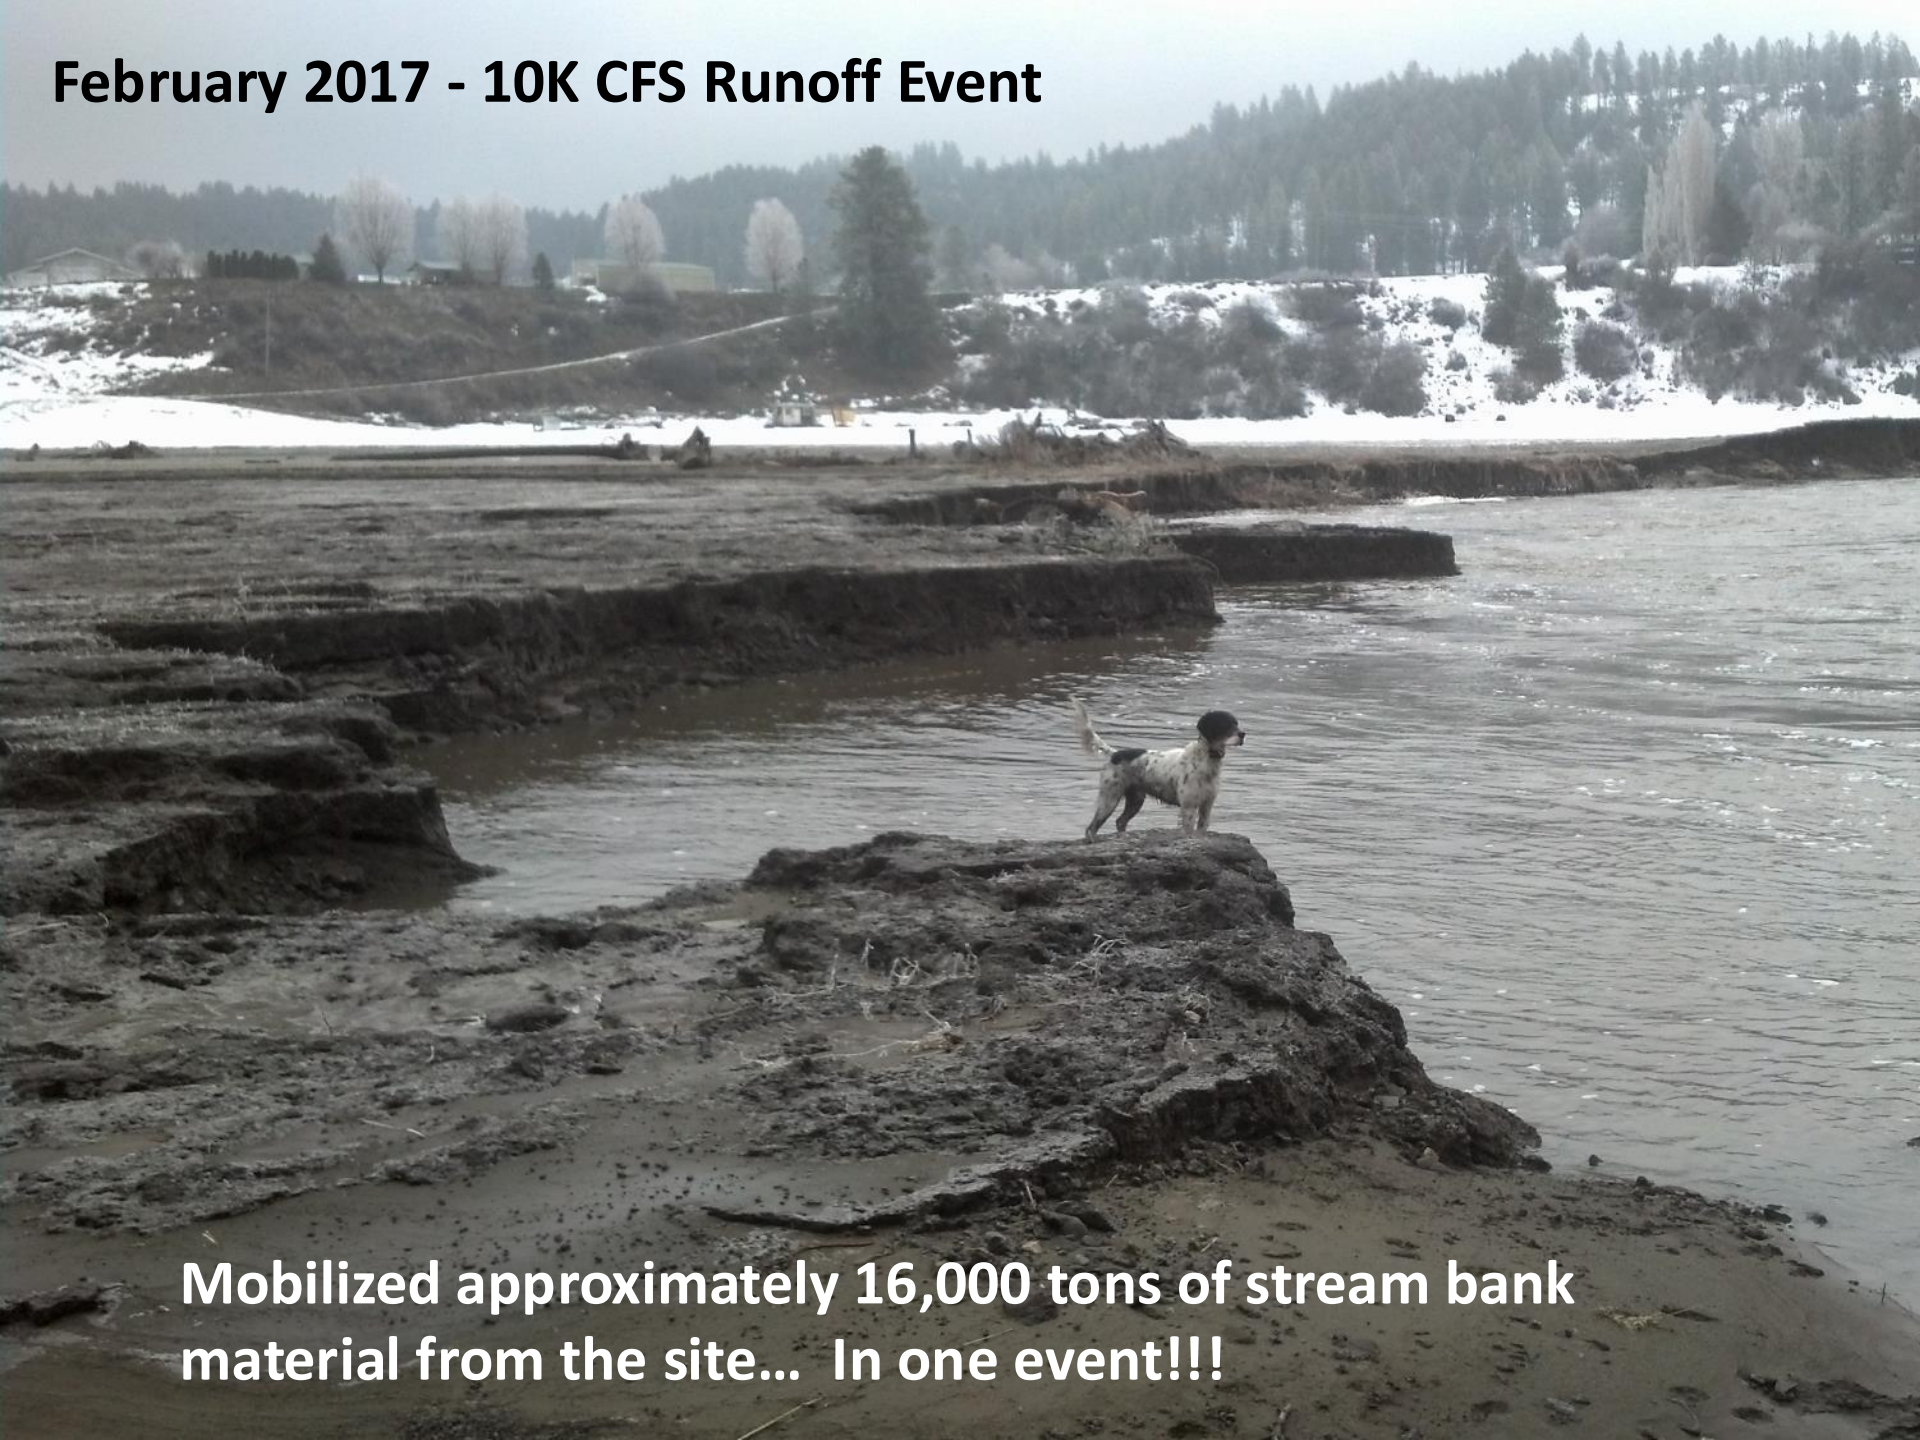
## February 2017 - 10K CFS Runoff Event

**Mobilized approximately 16,000 tons of stream bank material from the site... In one event!!!**
