#### Wolf Lodge Creek Watershed Restoration

Presented to the 2023 Spokane River Forum

Idaho Department of Environmental Quality and Kootenai-Shoshone Soil and Water Conservation District

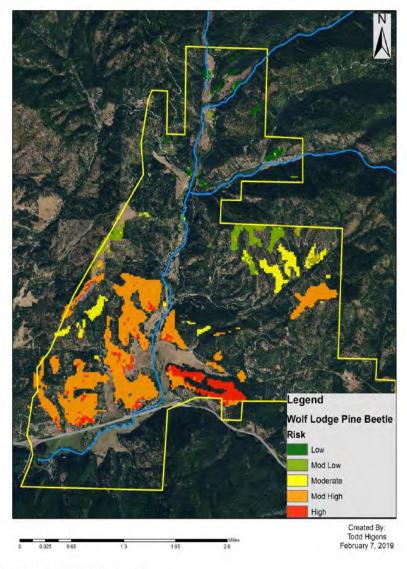
## Pine Beetle Risk

Based on Ponderosa Pine community and canopy density

Data Sources: WCG LiDAR, LandFire

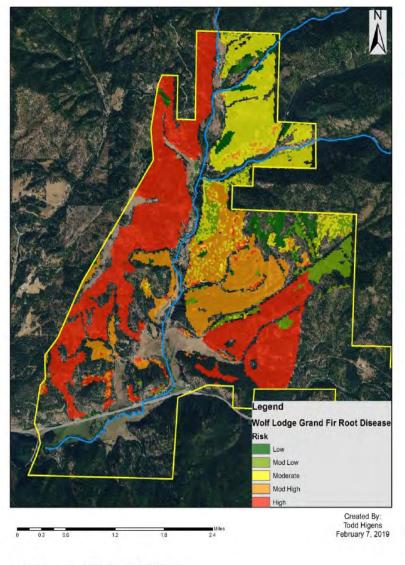
### Root Disease Risk

Based on Grand/Doug fir community, canopy density and canopy height

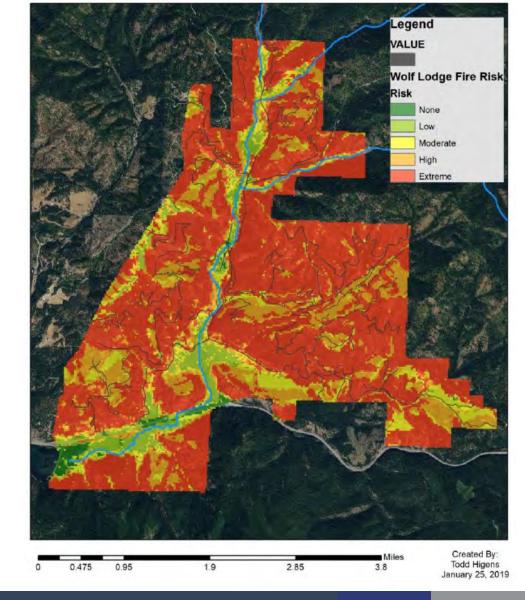
#### **Fire Risk**

#### Based on LiDAR, IDL, USFS, and LANDFIRE Data Sources

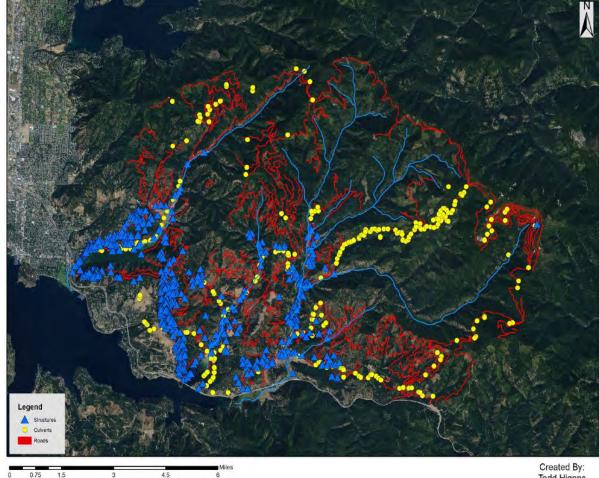
### Roads Culverts & Structures

298 culverts

165 need some formof maintenance52 only need to becleaned

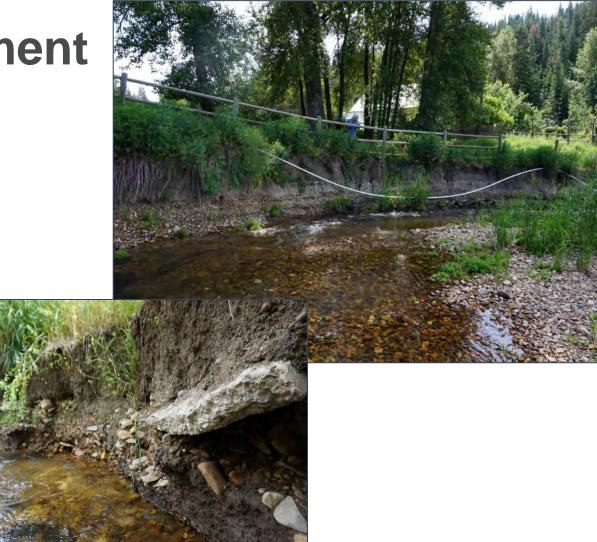
# Where is Sediment Coming from?

Bank erosion in valley bottom mostly on private property

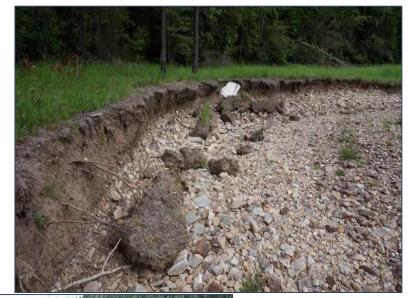
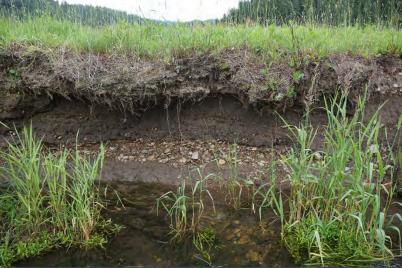
## Drivers for Channel Instability

Removal of vegetation

Dredging

Channelization

Increase peak flow

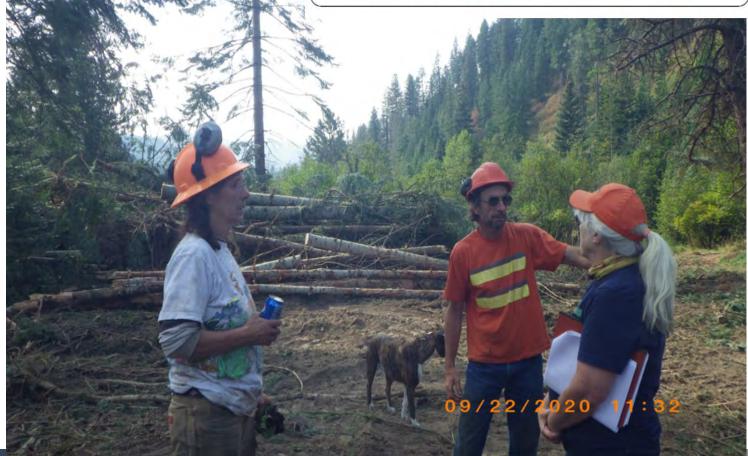
## **Bioengineering**

#### TOTAL WOOD QUANTITIES

ITEM	QUANTITY	DIAMETER	LENGTH	ROOTWAD
CATEGORY 1 WOOD	80	12-18 IN	25 FT	YES
CATEGORY 2 WOOD	1,885	6-12 IN	20 FT	OPTIONAL
CATEGORY 3 WOOD	3,341	3-6 IN	10-12 FT	OPTIONAL
WILLOW CUTTINGS	24,605	0.25-1.0 IN	8 FT	NO

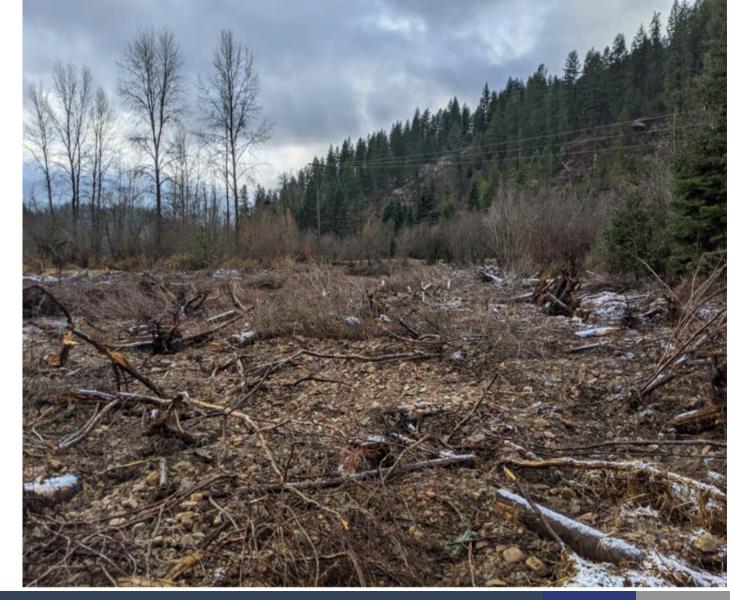
#### Floodplain Reconstruction

- floodplain swales
- large wood placement
- revegetation
